MANUFACTURING SAFETY ALERT

Fire from Hot Work Hazard

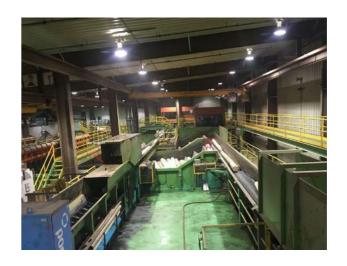
An employee was grinding and welding cracks on a step feeder.

The spark-watch was downstairs watering down the area below when he noticed a small fire under the log bin by the canter infeed conveyor.

The fire started in the framework of the conveyors in the basement and flashed up to the main floor through the opening between the two conveyors.

By the time the spark-watch accessed the area of the fire it had grown significantly. The fire was extinguished in a few minutes.

- Sparks from the grinding travelled past the wet down area to a conveyor which is an auto oiled conveyor. This always has oil on the slides, chain, and pan.
- The welder, spark-watch and supervisor did not see the conveyor as a hazard due to the distance from the hot work.
- Oily areas near hot work must be factored in prior to starting hot work.
- Removal of all combustibles in areas adjacent to hot work is the standard for safety.

Removal of all combustibles in the hot work zone will help to eliminate fires.
