# MANUFACTURING SAFETY ALERT

### Fibre Pile Fatality

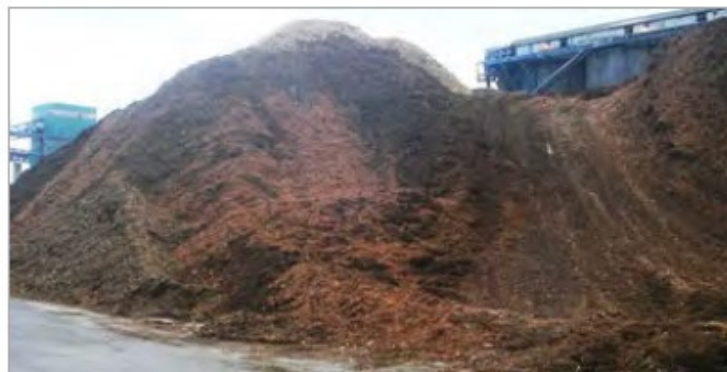
A tragic event recently occurred in north-central Alberta where wood fibre was being stored for use on oil & gas drilling sites. Smoke or steam was noticed coming from a fibre pile and a worker was sent to investigate. While they were on the pile, it collapsed, and the worker was engulfed and deceased

When fibre is stored in piles; over time self-heating and combustion can occur. The smouldering can continue for months and can eat out gaps in the fibre that can collapse with any weight. As snow cover on the pile melts in spring, wind can also expose the smouldering and open flames can result.

- Workers and equipment must not climb up on fibre that is suspected of self-heating.
- Restrict public access to fibre storage areas.
- Use FLIR camera to identify hot spots early.
- Use trained fire brigade or local fire department to safely expose and extinguish fibre pile smoulders/fires.
- Use good pile building & management practices.

Workers and equipment must not climb up on fibre piles that is suspected of self-heating.
