MANUFACTURING SAFETY ALERT

DESCRIPTION OF EVENT

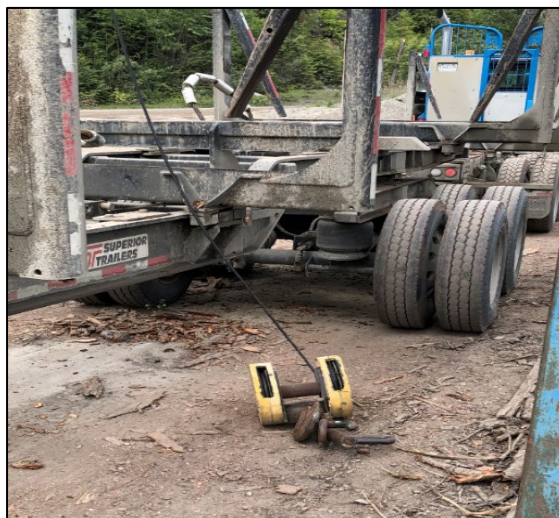
During a log truck trailer lift, the trailer loader hoist cable broke causing the trailer to drop two feet and hit the ground. The cable broke during the start of the lift and did not result in any injury.

The trailer hoist had a third-party annual inspection performed only six weeks prior to the incident, and no deficiencies were communicated by the 3rd party inspector. The inspection report was submitted two days following the incident and several deficiencies were identified, including damage to the wire rope.

Ensure crane inspections results are reviewed immediately and before the 3rd party inspector leaves the site so that deficiencies can be addressed in a timely manner.

1. Ensure daily inspections are performed and documented by trained personnel on trailer loader hoists. Deficiencies must be communicated to Supervisor/Manager without delay and the equipment locked/tagged out.
2. Establish a cable replacement frequency and incorporate in preventative maintenance schedule.
