# MANUFACTURING SAFETY ALERT

### AEROSOL BATTERY TERMINAL PROTECTOR & FIRE

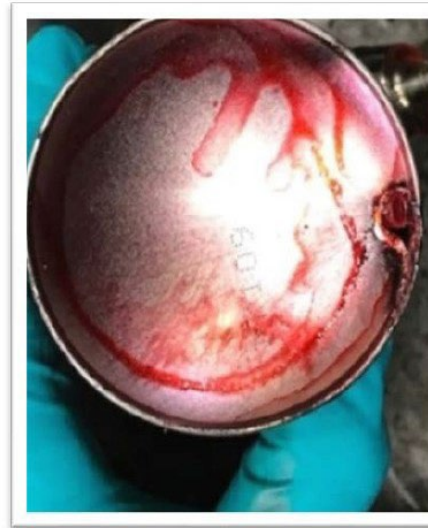
A service person was performing routine battery maintenance using an aerosol battery terminal protector on a haul truck's batteries. While spraying the aerosol the spray can contacted the positively charged busbar and the battery box lid strut, immediately causing a short circuit.

The arc created a hole in the bottom of the aerosol can and the contents of the can burst from the hole, igniting, and producing a fireball. The service person suffered first and second degree burns to their right hand, arm and face. Nitrile barrier gloves were being worn and the heat from the flames caused the glove to melt to the hand, creating complications during treatment.

- Consider performing risk assessments for non-routine tasks and when a task procedure changes.
- Encourage workers to stop and take a moment before conducting work to analyze the task and to identify hazards – both evident and subtle. Identified hazards then need to be controlled.

When working around live electrical equipment stop and assess the potential for arc flashes.
