SAFETY ALERT

Rock from log truck impacts ambulance windshield

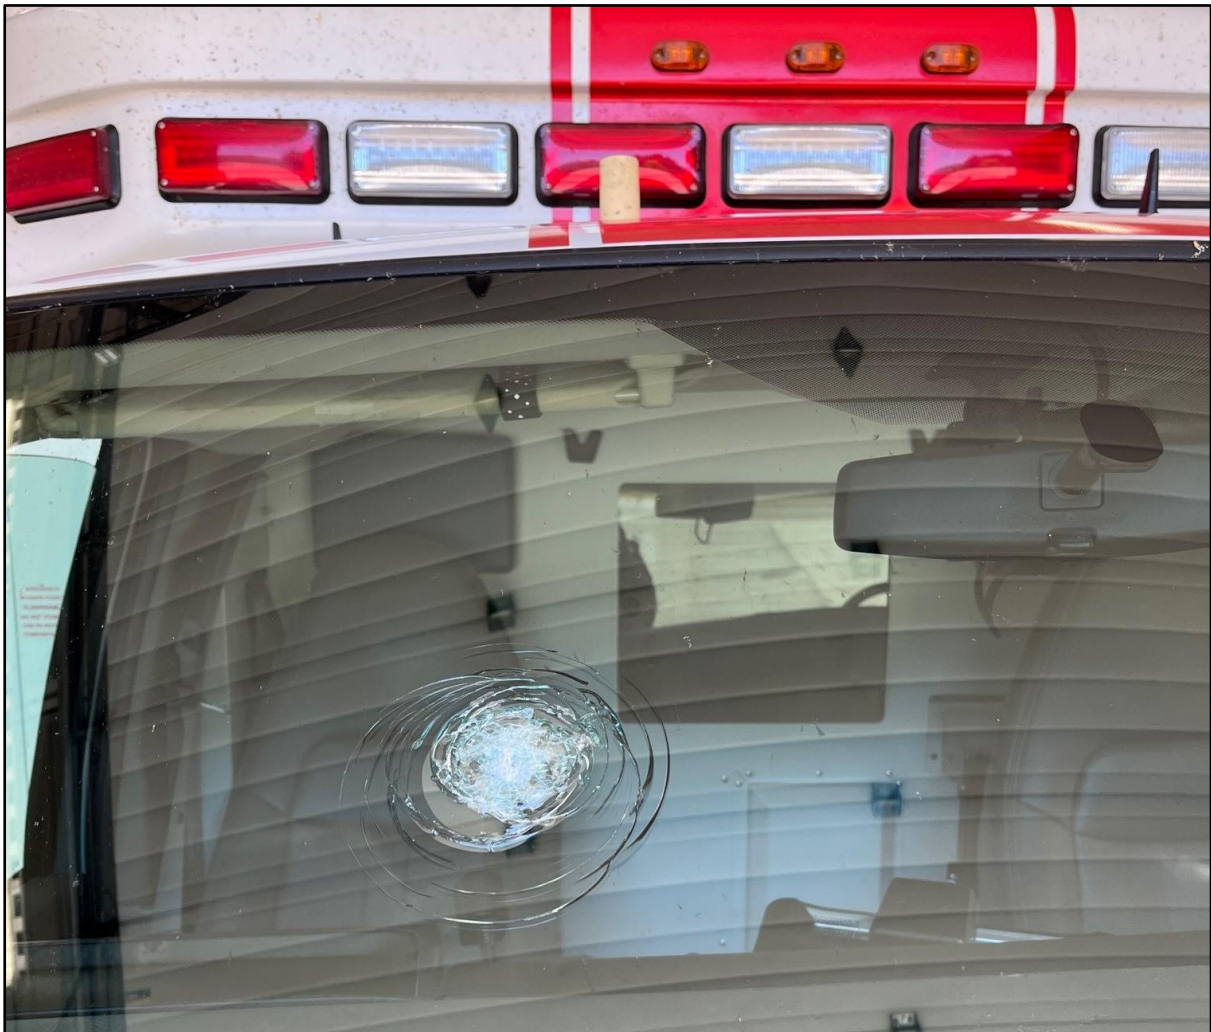
It was early afternoon on July 11 as an ambulance was returning to its station at Lake Cowichan on southern Vancouver Island. The emergency vehicle encountered two logging trucks travelling in the opposite direction. A large rock came off the second truck and severely impacted the windshield. Fortunately, no one was injured - however the ambulance was out of service for 2 days awaiting glass replacement.

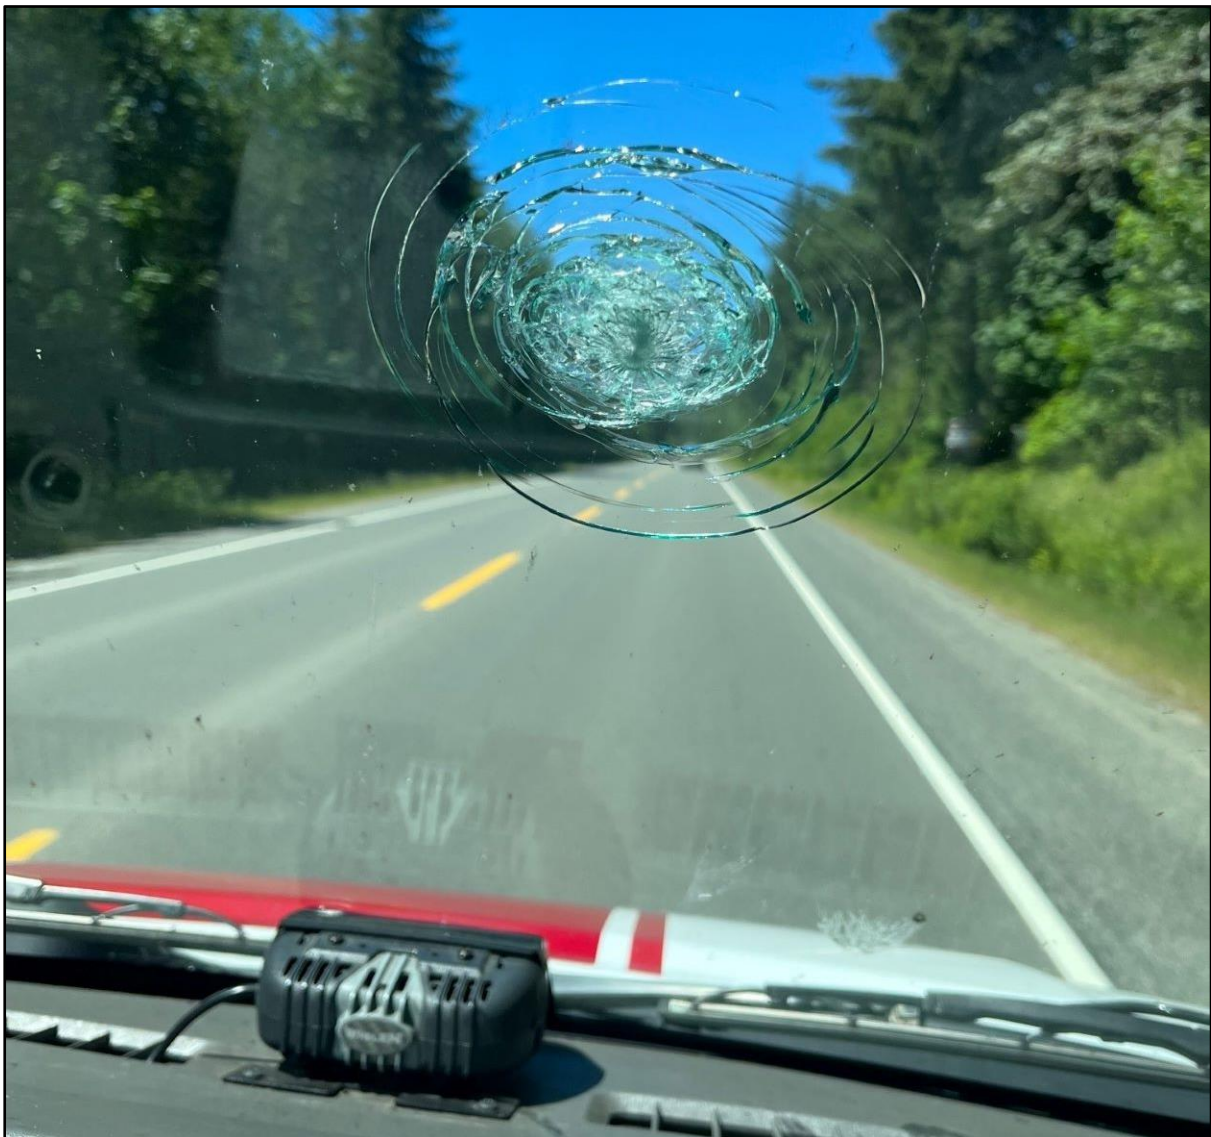
Loader operators and truck drivers must ensure that all logs are stable within the bunks and that there are no embedded objects such as rocks/small boulders that can fly off and cause damage (such as pictured).

Loader operators and log truck drivers both have a responsibility to identify unsafe loads that could result in an incident while being transported – particularly on public roadways.
