TAG

# SAFETY ALERT

## Rock Truck Brake Failure

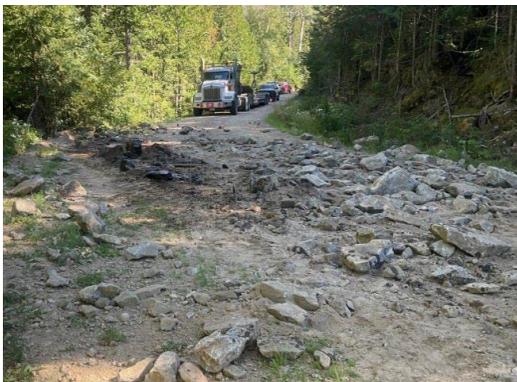
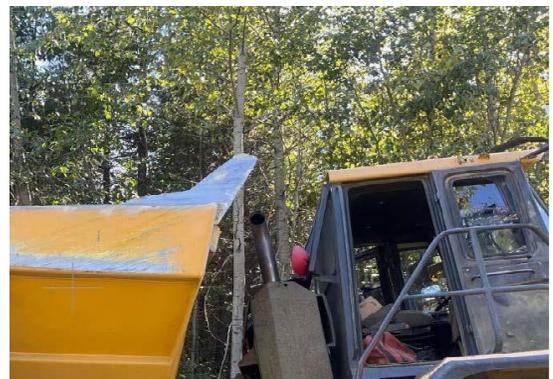
- An articulated rock truck was hauling down a sustained 10% grade when the engine retarder failed
- The driver applied the foot brake and park brake in an attempt to slow the truck
- Both brakes were unsuccessful in slowing the truck, so the operator purposefully spilled his load in order to stop the unit
- The cab stayed upright and the operator sustained scrapes and bruises from his seatbelt
- Prior to the event, the brake warning light came on while the rock truck was being loaded. The driver called the mechanic and they decided the operator should check the reservoirs and travel down in low range

- Ignoring safety warning systems
- Inadequate risk assessment of the worksite
- Inadequate pre-trip and post-trip inspection

- Ensure pre-trip and post-trip inspection are up to date
- Ensure maintenance records are up to date
- If brake warning indicator light comes on, machine needs to be taken out of service
- Consider all hazards associated with the job including slope and braking time
