MANUFACTURING SAFETY ALERT

Kiln Fan Deck Fall Hazard

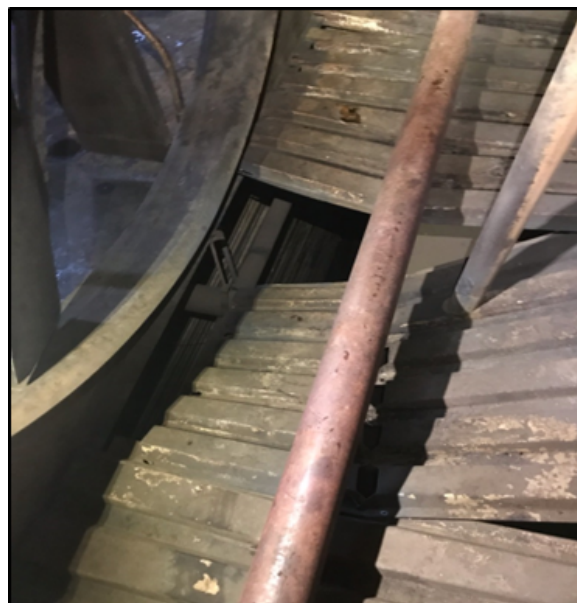
A worker was walking on the kiln's #2 fan deck, on the radiator side, checking fan hubs and blades.

They reached for a magnetic tool that a previous worker had left on deck when the floor gave way beneath their right foot.

The worker's foot fell through the hole 14 inches catching on a pipe.

The piece of flooring fell but got hung up on some fire protection pipes.

1. Inspect all kilns as per the “Kiln Inspection Checklist” and then annually thereafter.
2. Update the Computer Maintenance system to include inspecting flooring to monthly inspection (or by some other means to track this activity). Review Dry Kiln Preventative Maintenance.
3. The Kiln should be full of wood.

Remember to inspect all kilns as per the “Kiln Inspection Checklist” and then annually thereafter.
