# MANUFACTURING SAFETY ALERT

### **Kiln Fan Deck Fall Hazard**

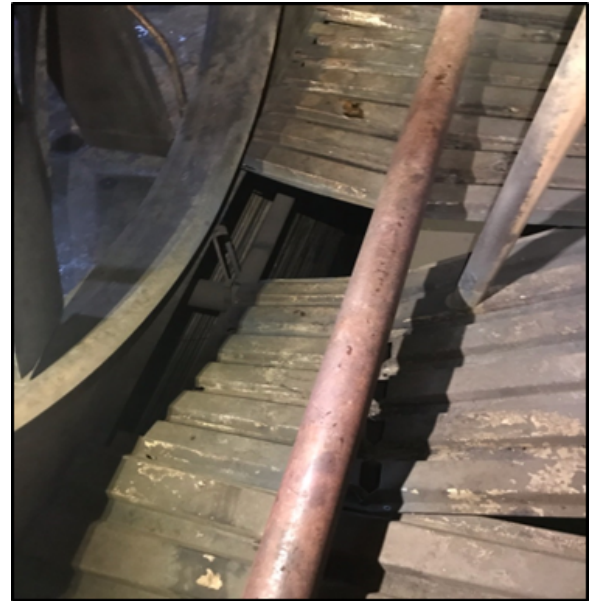
A worker was walking on the kiln's #2 fan deck, on the radiator side, checking fan hubs and blades.

They reached for a magnetic tool that a previous worker had left on deck when the floor gave way beneath their right foot.

The worker's foot fell through the hole 14 inches catching on a pipe.

The piece of flooring fell but got hung up on some fire protection pipes.

1. Inspect all kilns as per the “Kiln Inspection Checklist” and then annually thereafter.
2. Update the Computer Maintenance system to include inspecting flooring to monthly inspection (or by some other means to track this activity). Review Dry Kiln Preventative Maintenance.
3. The Kiln should be full of wood to break the fall of workers if the floor gives way.

Remember to inspect all kiln plenum floors before you go onto them. Never assume they can hold your weight or the weight of multiple workers performing maintenance duties.
