MANUFACTURING SAFETY ALERT

Forklift Pedestrian Incident

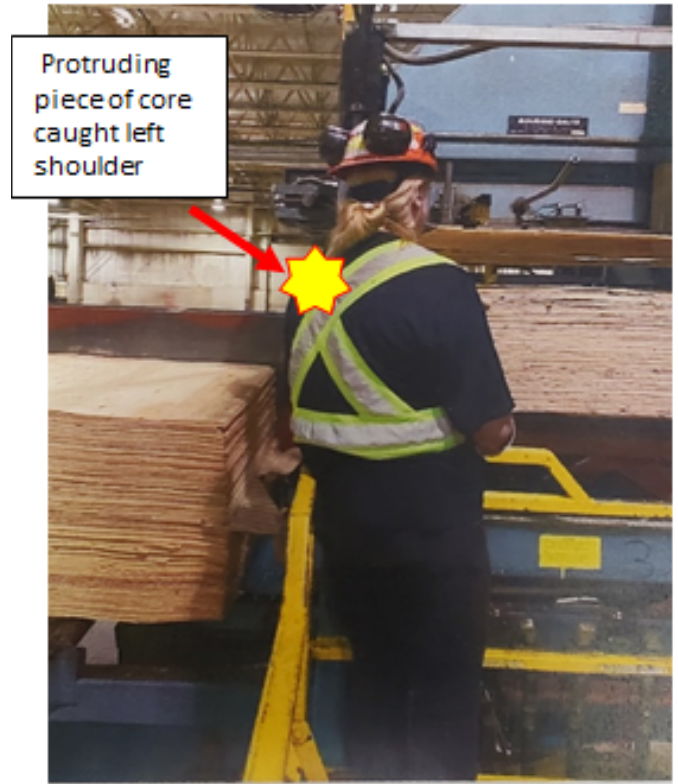
A forklift driver trainee was loading the core feeding station on the layup line.

A layup line operator-in-training was standing on the platform and leaning against the handrail by core feeder.

The forklift driver trainee lifted a load of core up and drove forward. A piece of core hanging out (approx 10") from the end of the load hit the LUL operator.

- Install guarding above handrail to prevent any overhangs or protrusions from core loads extending into the platform area.
- Communicate the incident with all forklift drivers and layup line operators about the hazards of standing too close to handrails while forklifts are loading infeeds.

Ensure forklift operators communicate with pedestrians in this area prior to entering the area with loads.
