MANUFACTURING SAFETY ALERT

Hog Chute Failure

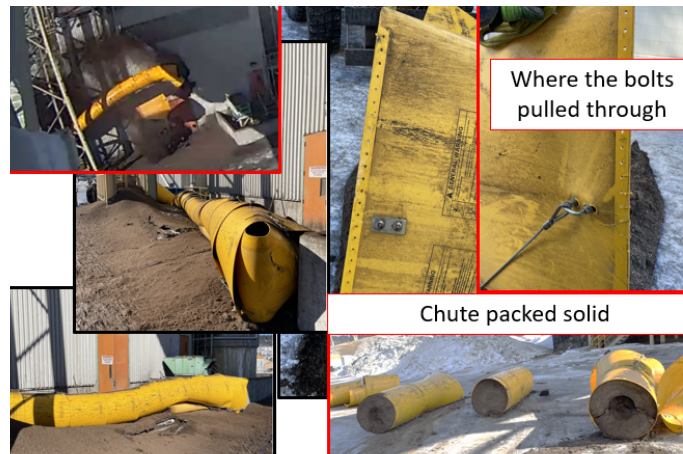
A loader operator pulled a bin from under a yellow chute that was directing hog from the galley. When the operator backed up, the bin struck the chute and it detached from the top and fell landing in front of a doorway.

The chute was fully compacted with frozen hog and very heavy.

- Investigate other chutes for similar hazards.
- Develop a pre-winter inspection process for all chutes to ensure there is no material buildup on the chute walls.
- Consider adding all chutes with potential to plug during cold weather to the monthly facility inspections.
