# MANUFACTURING SAFETY ALERT

### Hoisting Rigger Near Miss

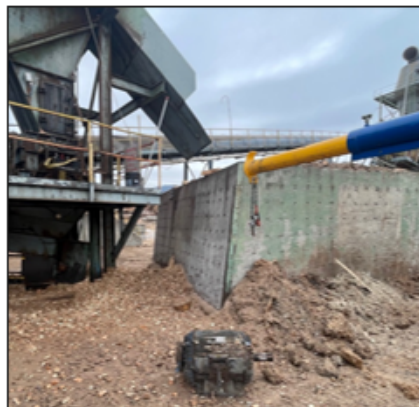
The maintenance crew was changing out a 150hp hog motor for the barkers. The telehandler operator was backing away from the machine and was starting to lower the motor to the ground when the lifting eye bolt failed and the motor fell to the ground.

Investigation of lift bolt, shows it was the wrong size. Speculate that this was done quite a few years ago when it was rebuilt

1. Use this incident as an opportunity for learning. Discuss near-miss events with the maintenance team and recommend control measures.
2. Review the control measure/procedure for lifting motors/devices/products using lifting bolts. Discuss the removal, inspection (including the hole threads), re-installation and the bolt fit (must fit tightly).
3. The Maintenance Correct Work Procedure or work order should include the recommended control measures for lifting heavy items.
4. Consider performing an FLHA specific for hoisting and lifting equipment that is over a threshold weight, such as motors. Additionally, consider the technical ability of the lift and whether the technical aspects of the lift need to be considered.

Consider performing an FLHA specific for hoisting and lifting equipment that is over a threshold weight, such as motors. Additionally, consider the technical ability of the lift and whether the technical aspects of the lift need to be considered.
