MANUFACTURING SAFETY ALERT

Serious Finger Injury New and Young Worker

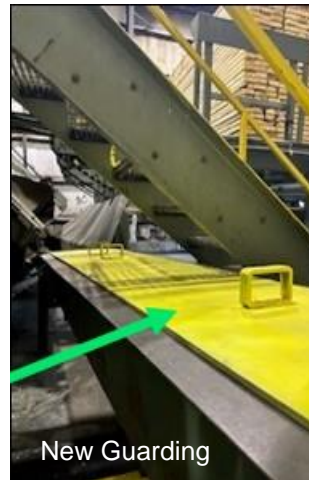
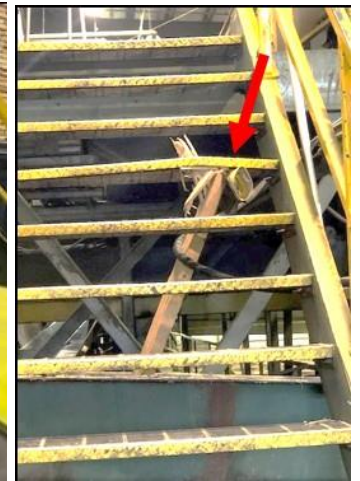
A new and young worker noticed a board hanging on a loose wire above a conveyor. They attempted to knock it off the wire. It caught on the conveyor and the board was pushed up through the bottom of the stair tread pinching the worker's thumb between the stair tread and the board.

- Review the FLHA use expectations training at the mill.
- Install safeguards on open conveyors located under open stairs or catwalks where there is a risk of protruding hazards that could injure workers.
- New employee orientation should specify hazards for workers without experience in industrial environments.
- Complete a full mill inspection for potential hazards from conveyors located under stairs or catwalks.

Perform a risk assessment on all conveyors to identify potential protruding hazards that could injure workers.
