MANUFACTURING SAFETY ALERT

Big Canter Ejected Log

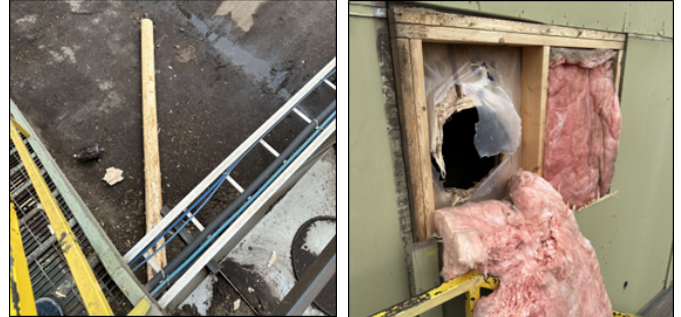
When investigating the unusual noise the operator noticed a hole in the wall where a log went through and landed on the ground narrowly missing an electrical truck.

Upon further investigation, the backing plate which was in place to stop logs that were being reversed was found broken on the ground.

- At the start of each shift a pre-use inspection of the equipment/machine center should take place.
- Consider developing a check list of critical safety controls to check at the start of each shift.
- Review Maintenance PMs to prevent the occurrence of similar incidents.
