MANUFACTURING SAFETY ALERT

Near Miss Log Dump Incident

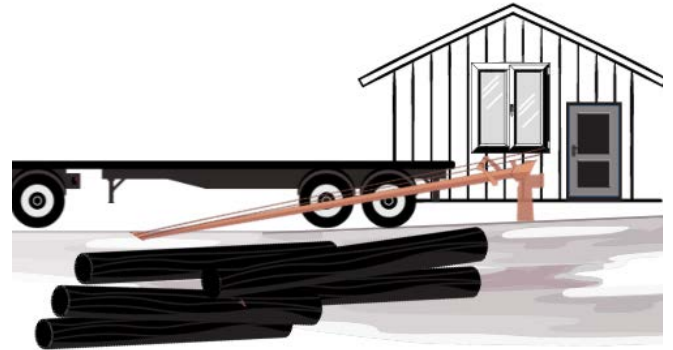
A truck arrived late at the log dump so the employee returned to work to dump the load. Due to low water levels the worker lifted and swung the load instead of dropping directly into the water. The crane with a load limit of 46,000 kg failed and the crane mast dropped and clipped the back of the rear trailer.

The crane recently performed the annual inspection of the crane and the inspection was successful in that the crane was certified for operation. During the incident investigation broken strands were found in the two back guy wires at the base.

The investigation determined that swinging the load in combination with the broken guy wires may have caused the crane to fail.

- Ensure that required maintenance inspections and certifications are effectively and appropriately conducted to ensure the safe operation of the equipment. If needed increase the safety factors in the back guys and modify the bases to enable better inspections.
- Ensure that operators are trained in safe operation of the equipment and that safety observations are carried out to confirm safe performance.
- Ensure safe operating procedures identify comprehensive hazard zones and associated processes to keep workers clear of overhead risks, and that safety observations are carried out to confirm operators follow established safe work procedures.
- Create safe zone for truck operators to ensure they are out of the bite if there is a crane failure.

Ensure annual inspections are performed on all critical safety related controls, equipment and wires.
