SAFETY ALERT

Chain Shot Incident on Processor

Date of Incident: January 2024

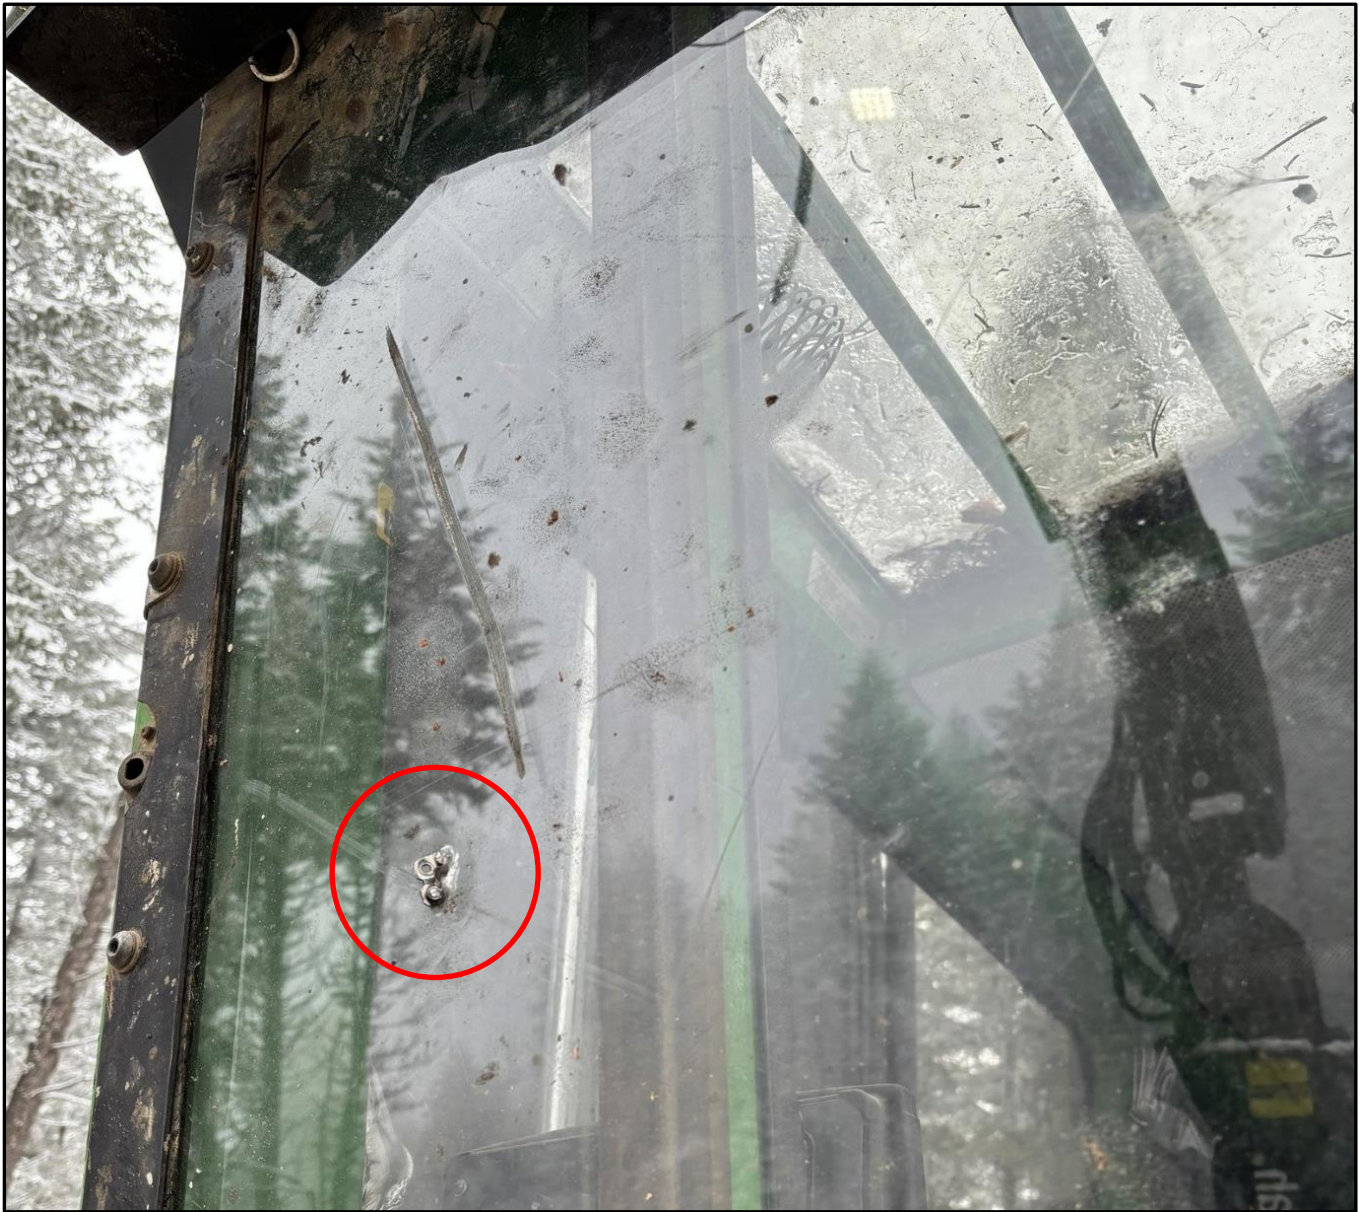
The processor's chain split, sending a couple of links into the windshield of the processor. The protective Lexan glass prevented the links from going through the windshield, doing its job in only allowing the broken pieces to embed in the windshield (see photos on the following pages).

- If a processor is running, workers must ensure the operator de-energizes the machine before approaching the work area.
- Monitor and check chains more closely for defects when sharpening.
- Do not position the processor head towards the cab of the machine, or in anyone else's direction.
- Do not stand in front of someone operating a chainsaw as chain shot can occur with hand-operated saws too!
