MANUFACTURING SAFETY ALERT

Arc Flash

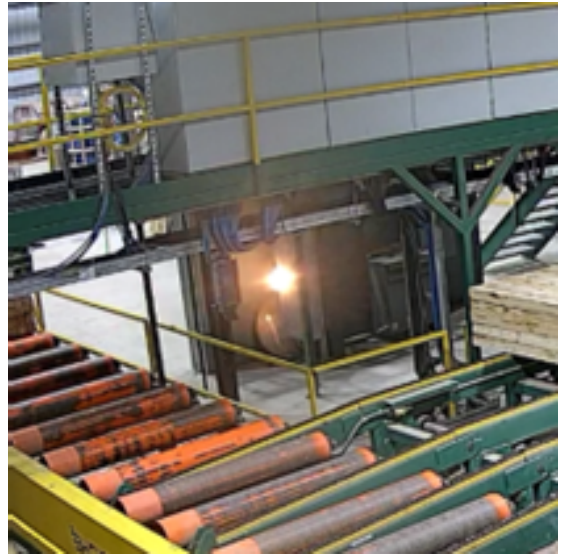
During normal operating conditions, a three-phase 60-amp breaker experienced an internal failure on the line side, resulting in an arc flash. This caused two additional breakers, including the main breaker, to trip.

Fortunately, no one was injured. Work was immediately suspended to allow for a thorough inspection of the panel. The area was secured with red tape to prevent unauthorized access.

- Review thermal scan process and frequency to ensure electrical issues are identified.
- Restrict access of potential arc flash areas to authorized personnel only.
- Send components off to determine cause of failure.
- Review plant for other panels that present arc flash risks outside MCC room.
