MANUFACTURING SAFETY ALERT

Falling Objects

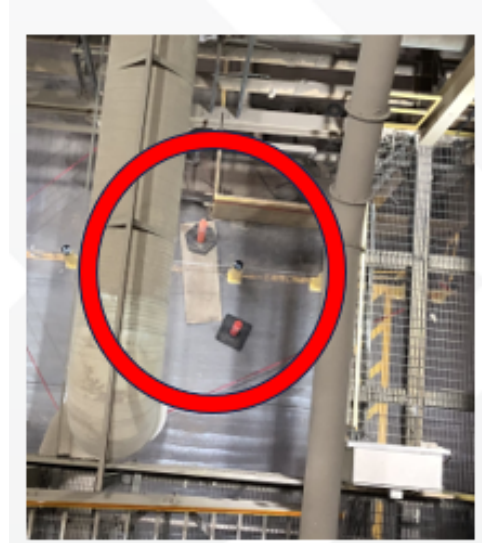
Contractors were removing lids from an in-feed conveyor in preparation for a job task. The conveyor was located at the top of the forming line approximately 70 feet above ground level. As one of the lids was being removed and handed off, the contractor on the catwalk lost control of the lid and it slid between the kick plate and mid-rail of the handrail, dropping to ground level below. The lid landed partially in the pedestrian pathway and partially in the main mobile equipment thoroughway.

At the time of the incident, a worker was traveling at ground level, and the lid landed about three feet in front of them. Fortunately, no injuries occurred. However, the ground area below did not have a red danger tape/tag barrier drop zone set up for the working-at-heights task.

- **Set up a drop zone:** Always ensure a red danger tape and tag control/drop zone is established when working at heights if there is a potential for objects to fall.
- **Control zone access:** Only workers involved in the job tasks and signed on to all required permits and tags should be authorized to enter the control zone.
- **Specific hazard identification:** Be specific when identifying hazards and the controls or mitigation measures.
- **Join the Canadian DROPS Chapter:** Consider joining to participate in ongoing efforts to prevent dropped objects. <https://www.dropsonline.org/about/drops-organisation/drops-canada-chapter/>
