MANUFACTURING SAFETY ALERT

Hot Work - Class III Fire

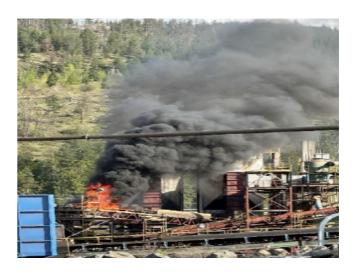
A fire broke out on a conveyor used to transfer residuals. Employees quickly responded by activating the fire alarm and applying water to the flames. The fire department was called for additional support.

After the fire was extinguished, a block of wood was discovered at the ignition point, showing signs of friction burns from contact with the moving belt. The exact cause of the fire is unknown as to whether it was due to the hot work or friction from the conveyor.

- Shut down conveyors that could carry sparks to nearby or distant combustible materials during hot work.
- Inspect and clean enclosed equipment or duct work to remove all combustible materials and ensure nothing is lodged or impacted inside.

Sparks or smoulders may be carried along conveyor systems to distant areas containing combustible materials. These systems must be regularly inspected for impacted material that may lead to friction fires. During hot work, conveyors need to shut down to prevent the propagation of spark of fire.
