# MANUFACTURING SAFETY ALERT

### Chipped Tooth Incident

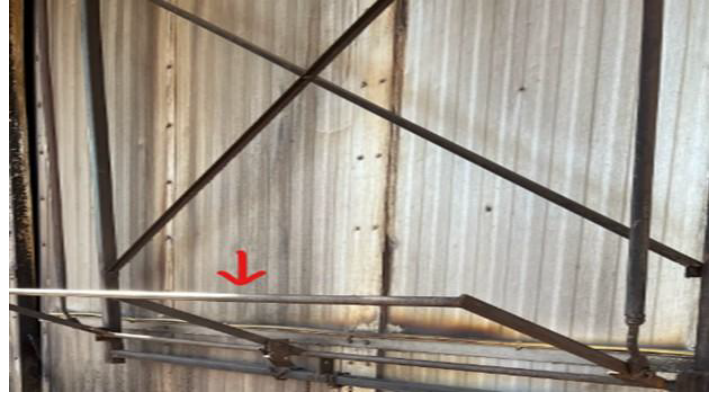
A kiln forklift operator was having difficulty positioning a carriage under a lift bracket and called for help.

While they were assisting, they let go of the handle to reposition the door. The handle swung down unexpectedly and struck them in the mouth, causing a small chip in a tooth.

- Share details of the incident with others who perform this task.
- Review current procedures and involve the safety committee in identifying improvements.
- Revisit the SWP and communicate any updates to prevent similar incidents.
- Update Job Safety Analyses (JSAs) for roles that may assist with this task.
- Remind forklift operators to report any issues with doors promptly, even if not mechanical.
- Reinforce the importance of staying focused and conducting hazard assessments before starting a task.
