# MANUFACTURING SAFETY ALERT

### Life-altering Hand Injury

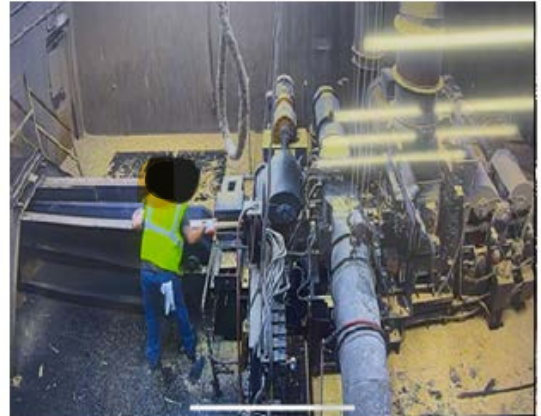
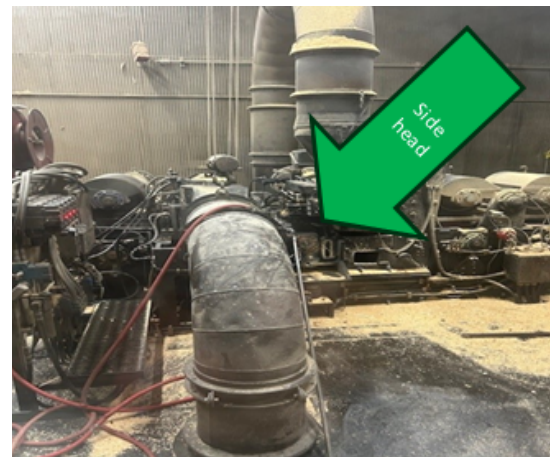
A planer feeder shut down the machine to investigate a jam near the outfeed roll and side heads. After completing the lockout procedure, the team member entered the planer room to remove a jammed board that was pinned by the outfeed roll.

They then exited the room, unlocked the machine, and restarted it to raise the outfeed roll. Once it was raised, they shut the machine down again and re-initiated the lockout—but did not re-verify that the lockout or confirm all parts had stopped rotating.

When they returned to the planer room to finish clearing the jam, their hand contacted a moving side head resulting in a life-altering injury.

- Ensure the mag lock on the planer room door requires three conditions to unlock and it remains locked when equipment is running.
- Investigate and implement a maintenance-specific LOTO (Lockout/Tagout) mode that keeps feed rolls and cutting heads in the open position.
- Reinforce that LOTO verification is mandatory every time, regardless of how recently the equipment was re-energized.
- Update all Safe Work Procedures (SWPs) to include instructions for shutting down equipment from the operator console.
- Re-emphasize the importance of thorough hazard and risk assessments, especially when discrepancies arise.
- Test and document shutdown braking times to ensure safe access after lockout.

**Before re-entering a planer room, always re-verify that the lockout is still in place and that all parts have stopped rotating.**
