# MANUFACTURING SAFETY ALERT

### Log Impact

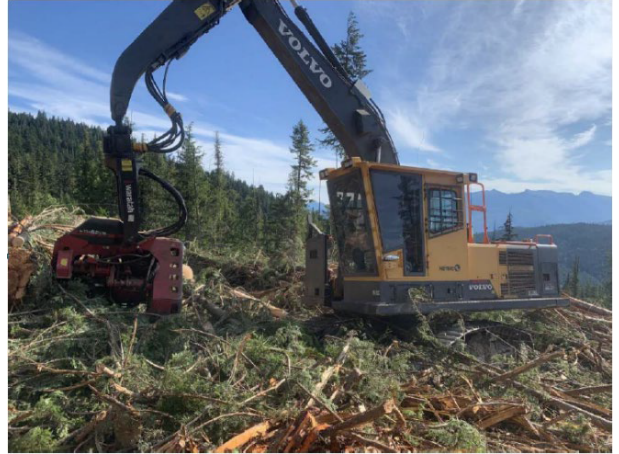
While processing a log, the operator was inspecting the butt end for signs of rot when they accidentally activated a preset control. This caused the log to feed forward and break through the cab window, stopping close to the operator's leg.

Fortunately, the operator was not injured.

- **Ensure Operator Protective Structures (OPS) meet regulatory standards:** OPS must comply with applicable regulations and be inspected regularly to ensure they provide effective protection from objects such as logs and branches.
- **Avoid directing logs toward the cab:** Operators should be trained to position and move logs in ways to prevent them from being directed toward the cab during processing.
- **Position equipment to reduce risk:** Place equipment in a position that lowers the chance of accidental log movement toward the cab, taking slope and terrain into account.
- **Ensure operators are familiar with their equipment:** Operators should know all controls and safety features of their equipment. When operating new or different machines, make sure they are briefed on any changes to controls, presets or protective systems.
