# MANUFACTURING SAFETY ALERT

### **Struck-By, Near Miss**

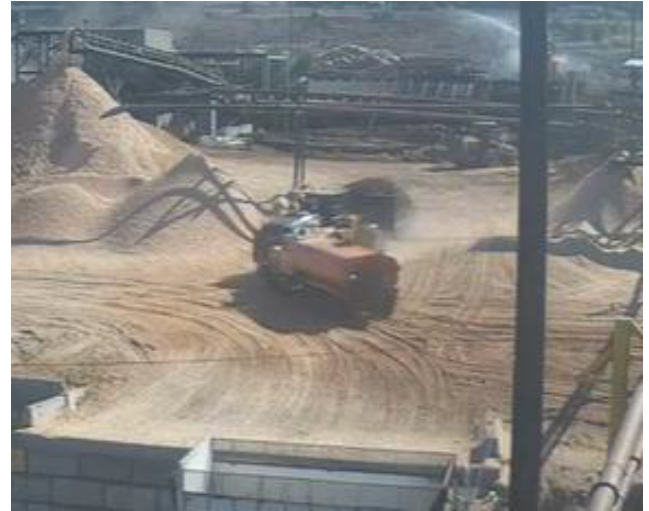
A bucket loader operator was working at a hog pile. While backing up, they narrowly avoided a collision with a water truck that had entered the area behind it.

Radio contact between the water truck operator and the bucket loader was not established as required by the safe work procedure. Fortunately, the water truck operator spotted the operator reversing in time to back out of the way before a collision could happen.

No injuries or damage resulted from this close call.

- Ensure radio procedures are followed whenever mobile equipment or pedestrians enter an active work area.
- When establishing radio contact, if you don't hear a response, don't enter the area.
- Instruct mobile equipment operators to thoroughly check behind them to ensure the area is clear before backing up.

Never assume that vehicle operators have heard your radio call or have seen you enter an area.

If you do not receive visual or radio contact with a clear response, do not enter the work area.
