# MANUFACTURING SAFETY ALERT

### **Serious Incident – Vehicle Damage Mobile Equipment Tip – Over (SIF)**

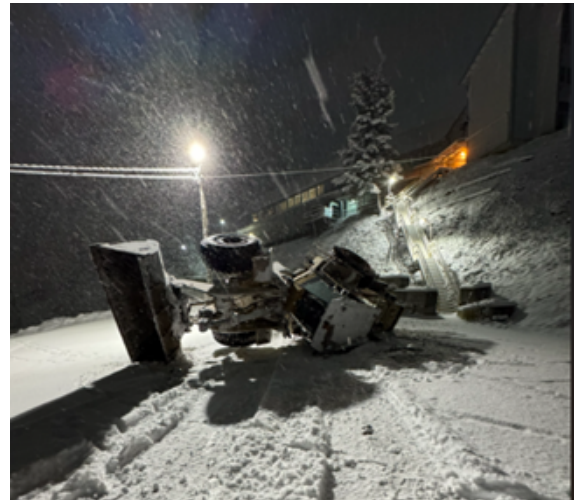
A contractor loader operator was driving downhill from the upper parking lot to lower woods lot to plow snow. When they rounded the corner at the top of the hill, the loader lost control and started sliding downhill with the wheels locked up.

As the loader continued to slide, the operator tried to steer away from a light pole at the bottom of the hill. While turning the wheels, the tires contacted a section of loose gravel beneath the fresh snow, suddenly digging in and causing the loader to tip onto its side.

- Update Snow Removal Safe Work Procedures (SWPs) to include clear requirements for hill and slope control, approved plowing methods on inclines and mandatory blade-down requirements in defined areas.
- Require proof of training and competency from heavy equipment contractors.
- Define contractor snow removal controls process.
- Implement annual contractor site indoctrination.
- Develop contractor snow removal hazard & control maps.
- Create snow removal call-in and authorization instructions.
